CUPERTINO CIVIC CENTER

MASTER PLAN DOCUMENT APPENDICES

JULY 2015

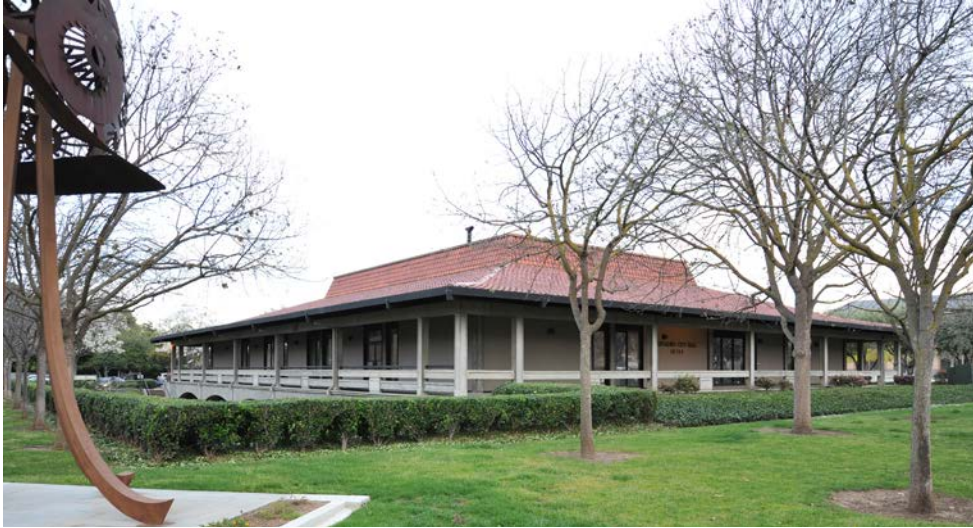
B: IMMEDIATE OCCUPANCY + EOC

STRUCTURAL (IMMEDIATE OCCUPANCY)

- Additional shear walls at ground level
- Seismic Bracing of MEP equipment
- Extensive Roof Reinforcement
- Concrete Column Reinforcement (Fiber Wrap required)
- Thickening of shear walls at basement

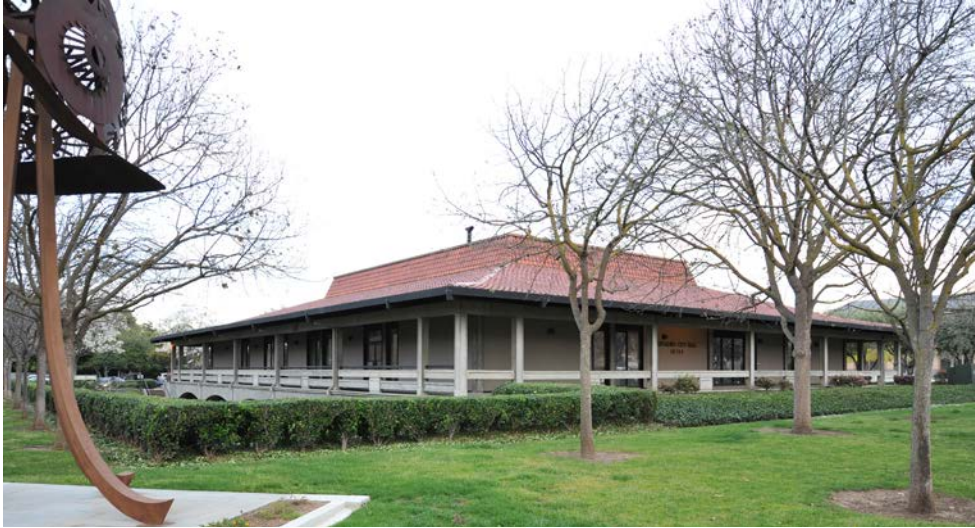
C: COMPLETE REMODEL

STRUCTURAL (IMMEDIATE OCCUPANCY)

- Additional shear walls at ground level
- Seismic Bracing of MEP equipment
- Extensive Roof Reinforcement
- Concrete Column Reinforcement (Fiber Wrap required)
- Thickening of shear walls at basement
- Additional slab reinforcement at lightwell openings

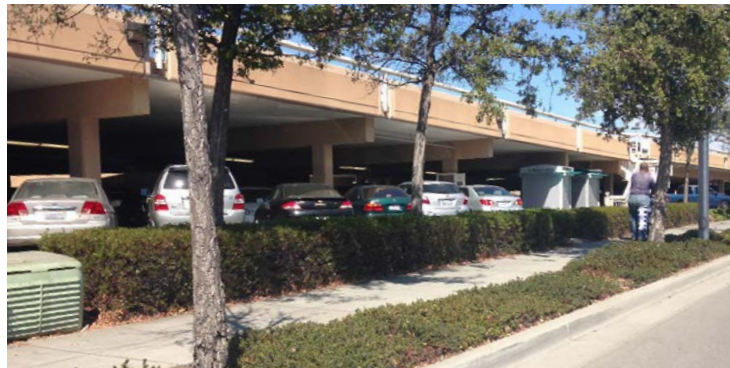
P2: BEHIND LIBRARY- ABOVE GROUND

Parking garage with 1 deck level (estimated at 15' high) located behind library on existing surface lot. Accounts for 100 additional spaces and replacement of 130 existing spaces.

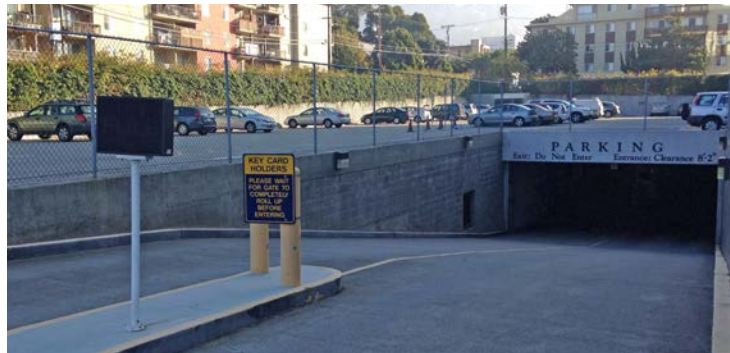
Underground Parking

Parking garage with 1 level below ground located behind library on the existing surface lot. Accounts for 100 additional spaces and replacement of 130 existing spaces.
