CUPERTINO CIVIC CENTER

MASTER PLAN DOCUMENT APPENDICES

JULY 2015

PERKINS
+ WILL

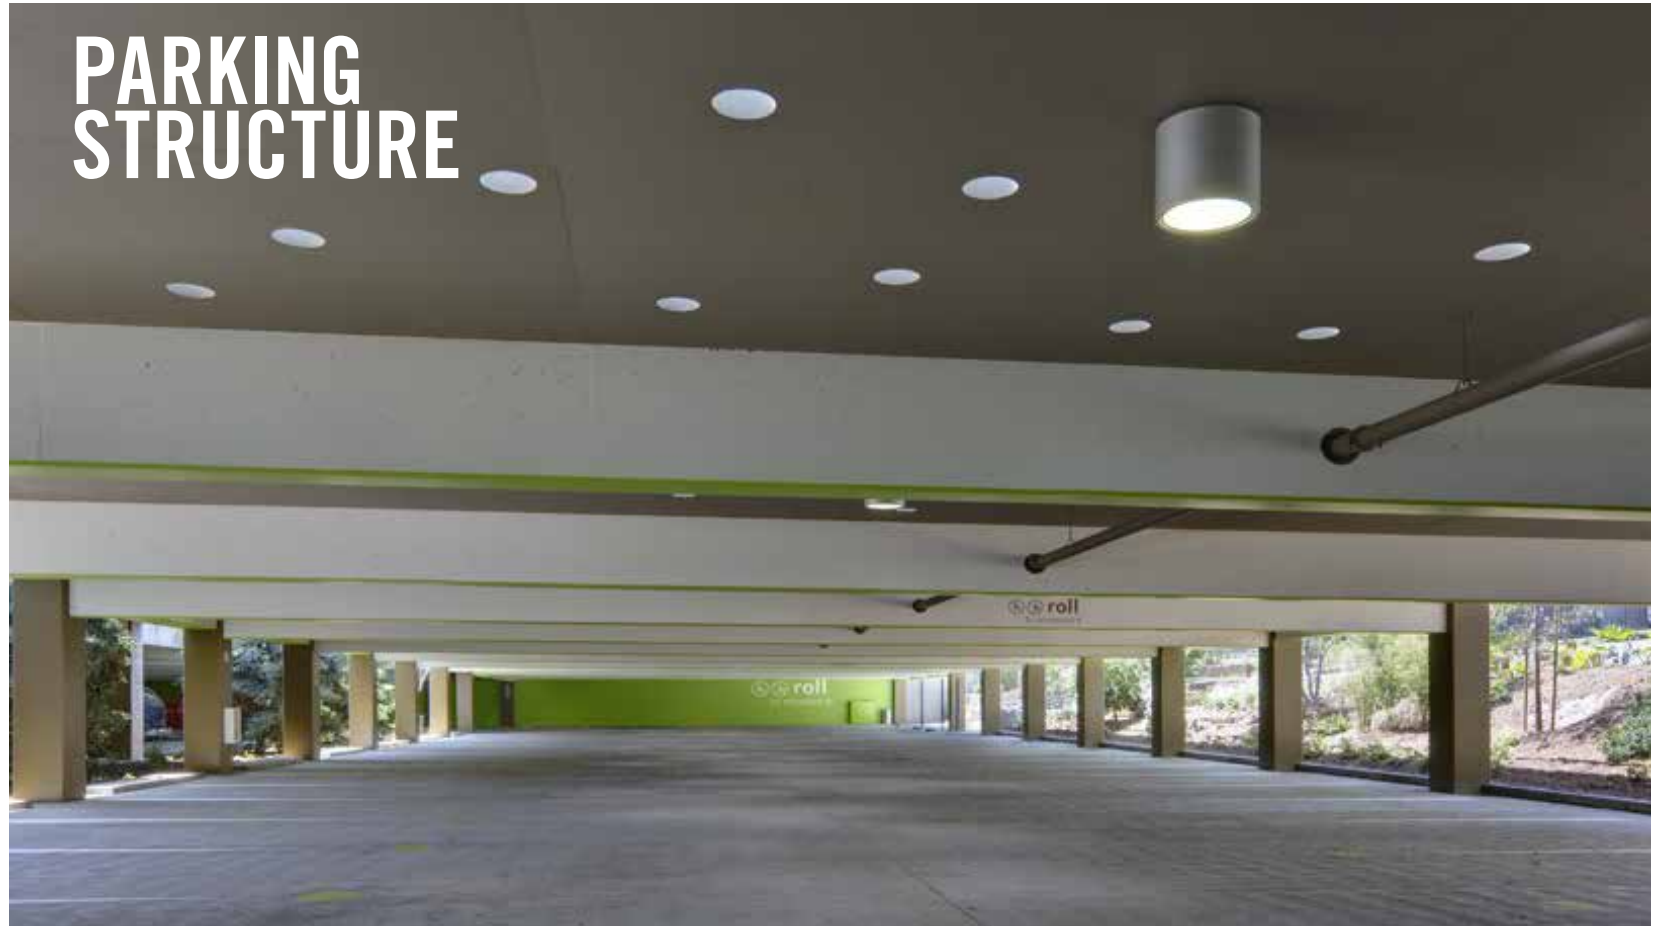
PARKING STRUCTURE

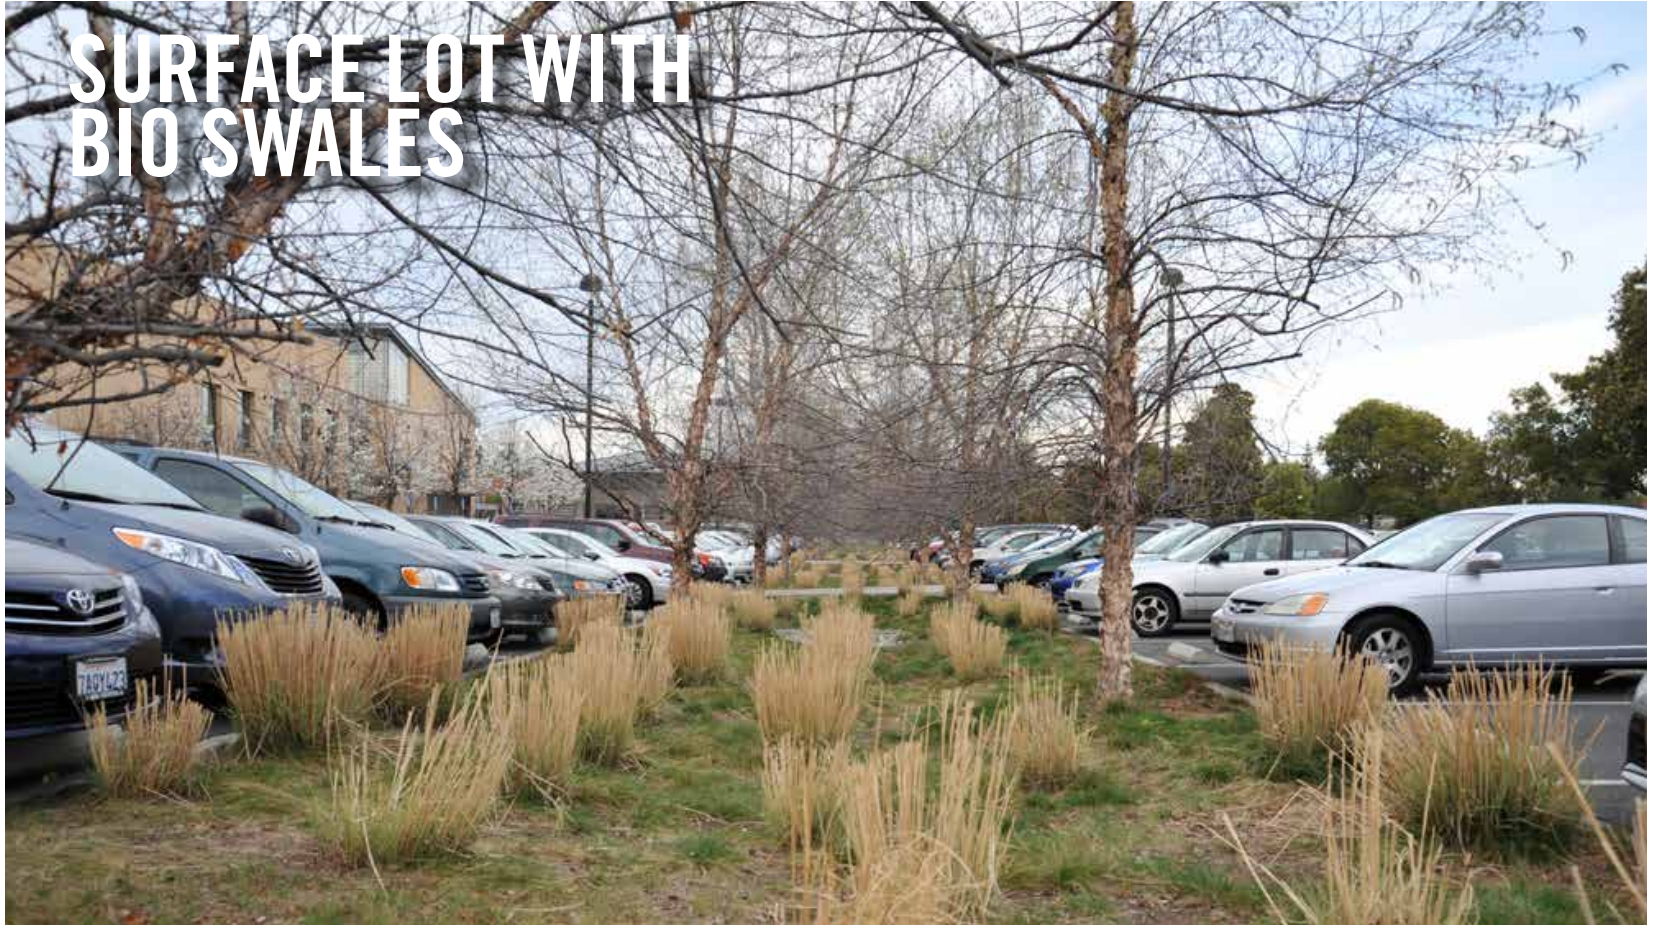
SURFACE LOT WITH BIO SWALES

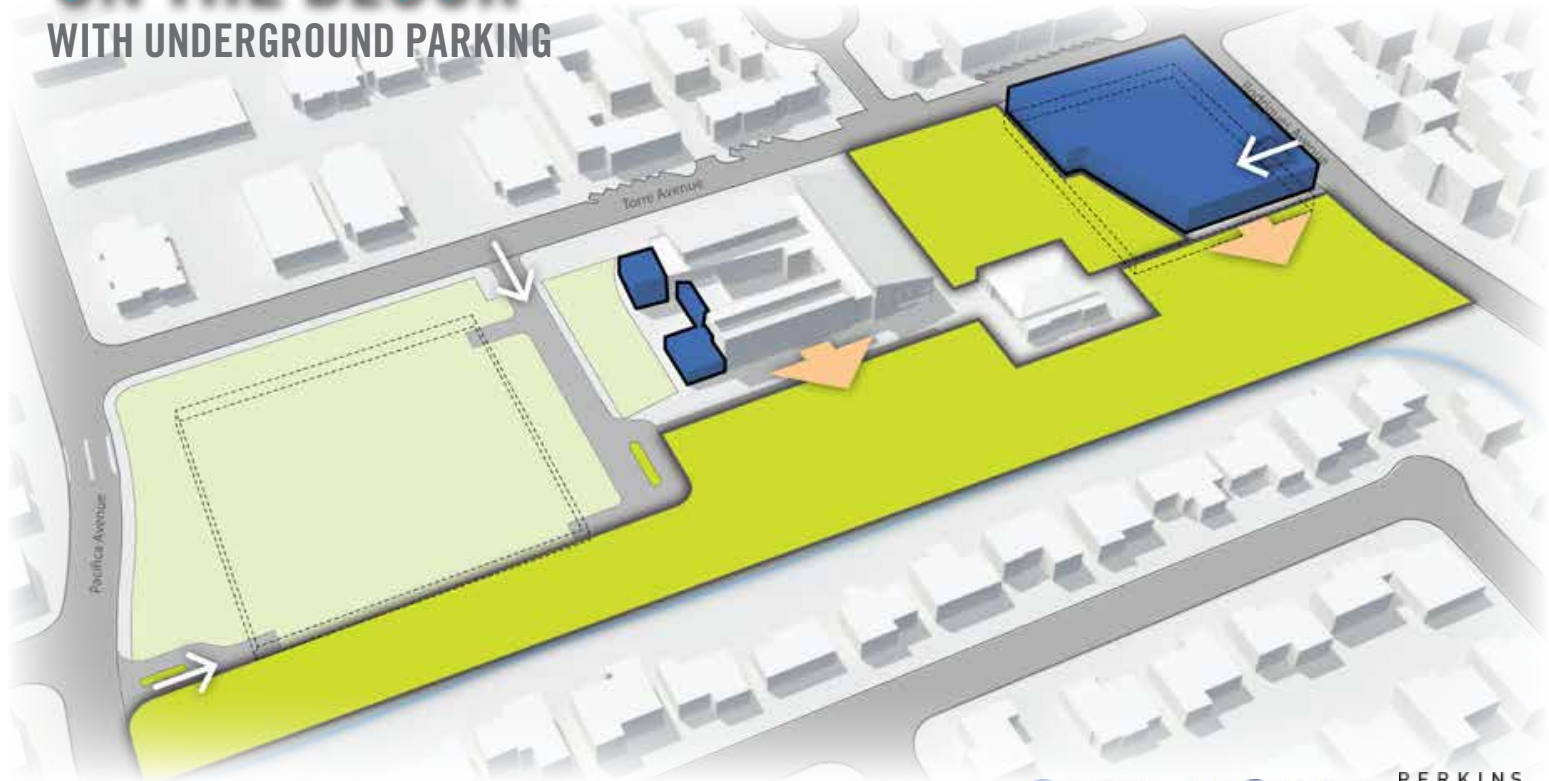
“ON THE BLOCK”

WITH UNDERGROUND PARKING

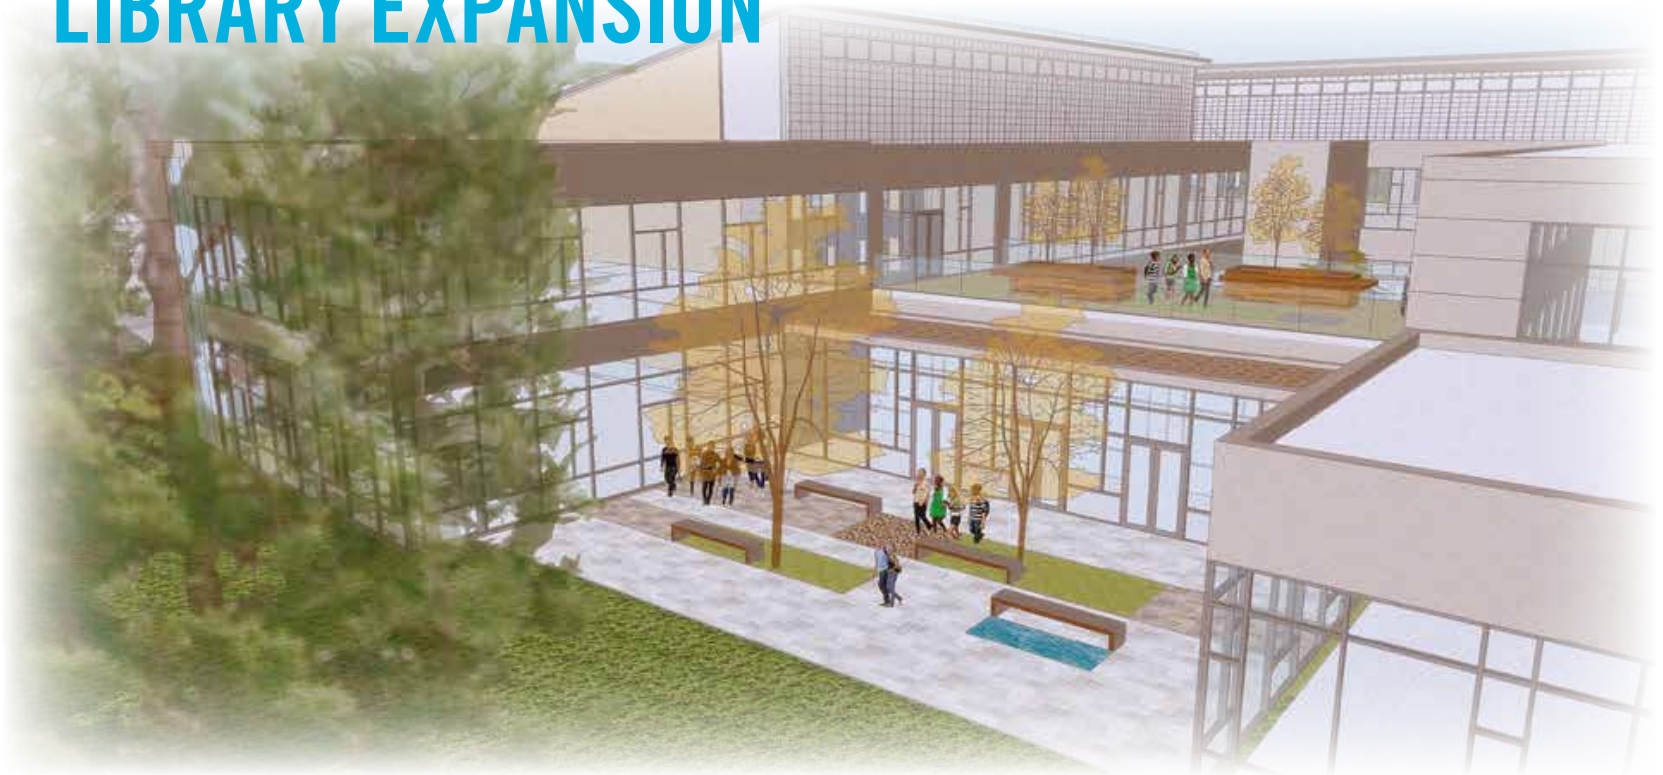
CIVIC LIFE MASTER PLAN LIBRARY EXPANSION

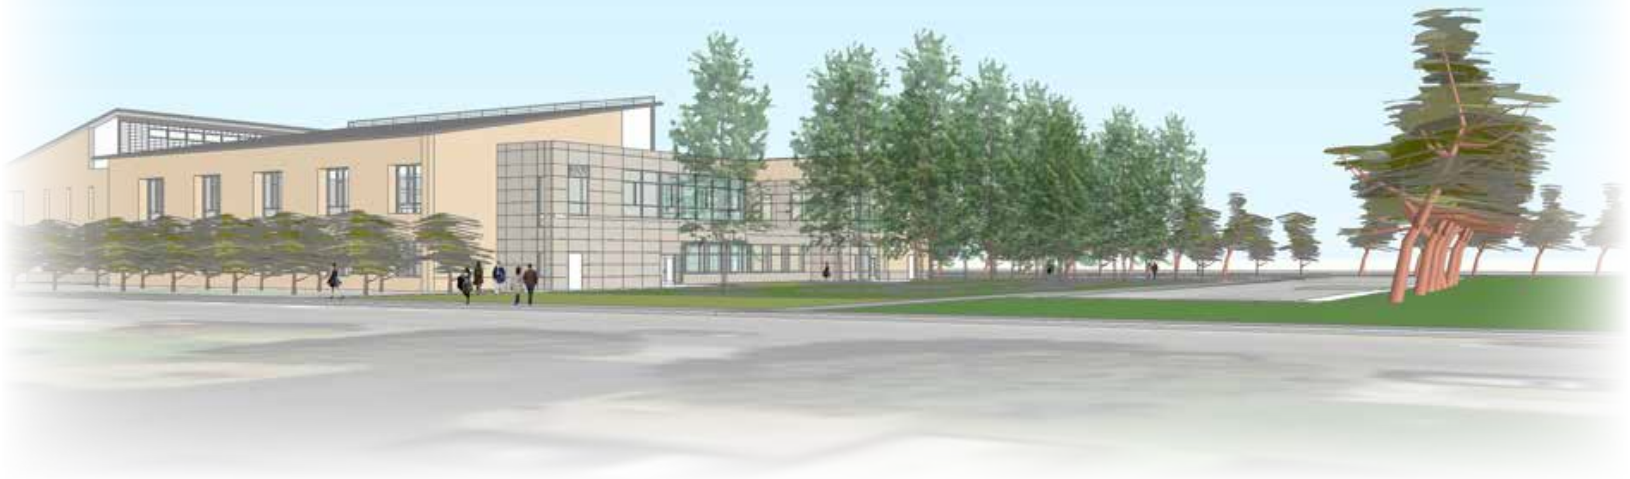
LIBRARY EXPANSION

EXISTING

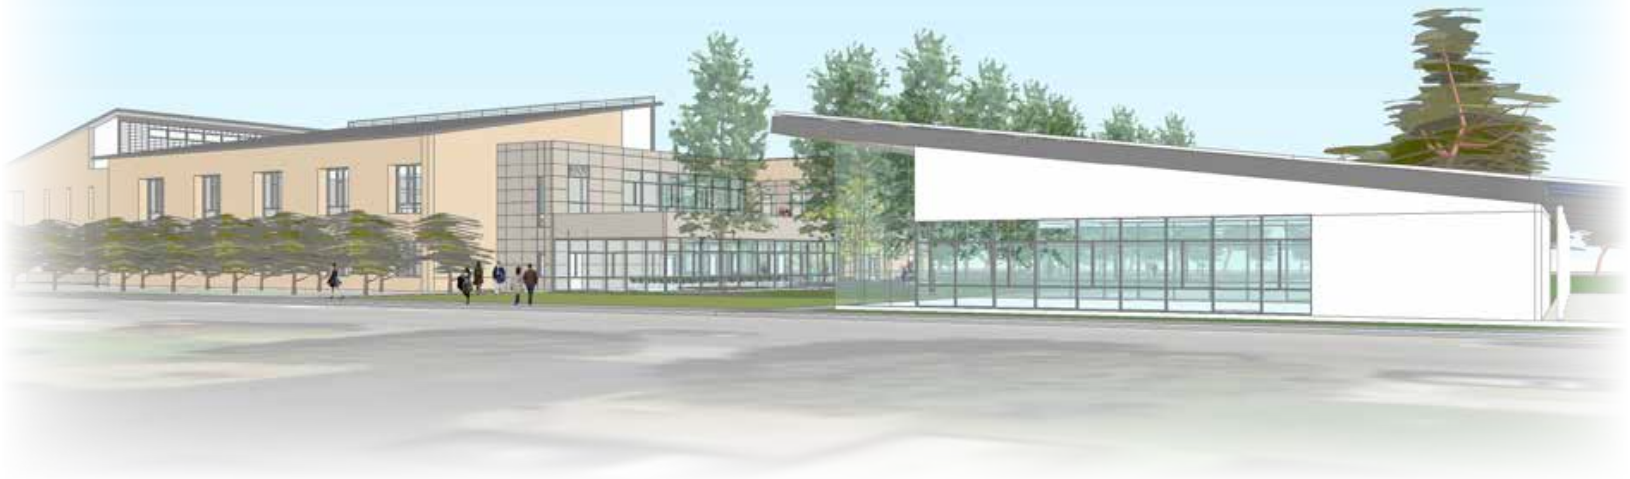
LIBRARY EXPANSION

WITH STAND-ALONE TEEN CENTER

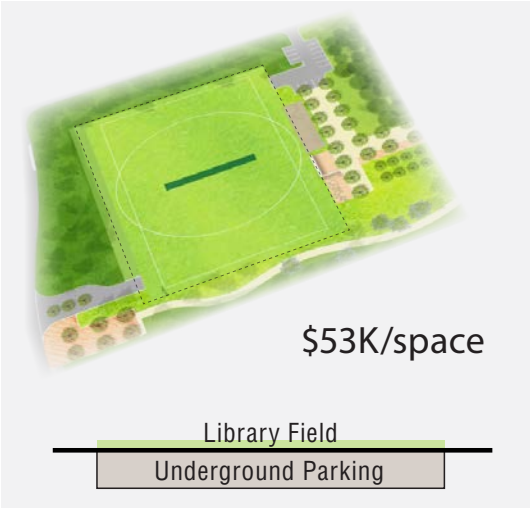
UNDERGROUND PARKING BELOW LIBRARY FIELD

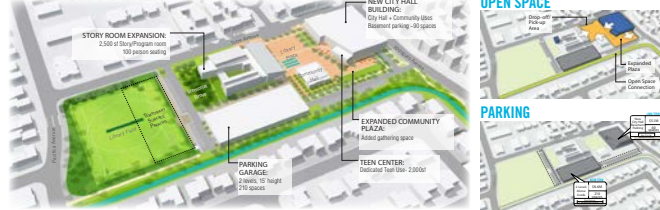
OPTION 1 - "CITY PLAZA"

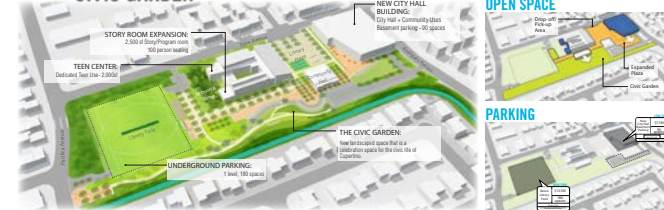
OPTION 2 - "CIVIC GARDEN"

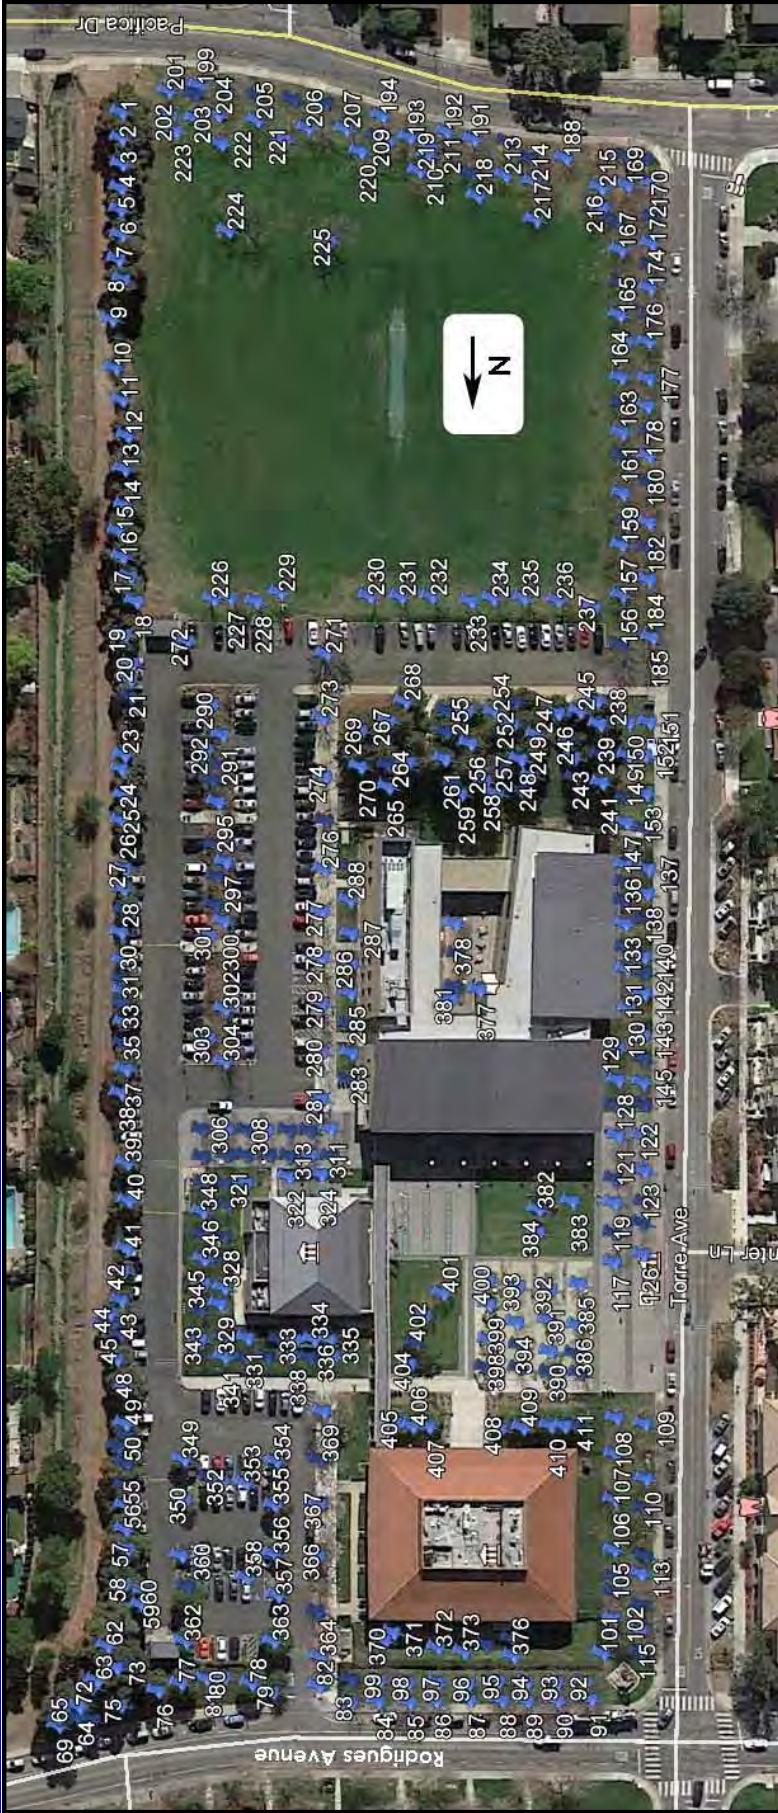
TREE MAP #1 COMPLETE COMPLEX

Note that separate, larger copies of the Tree Maps in this report have also been provided as .PDF files, along with an online interactive .KMZ file.

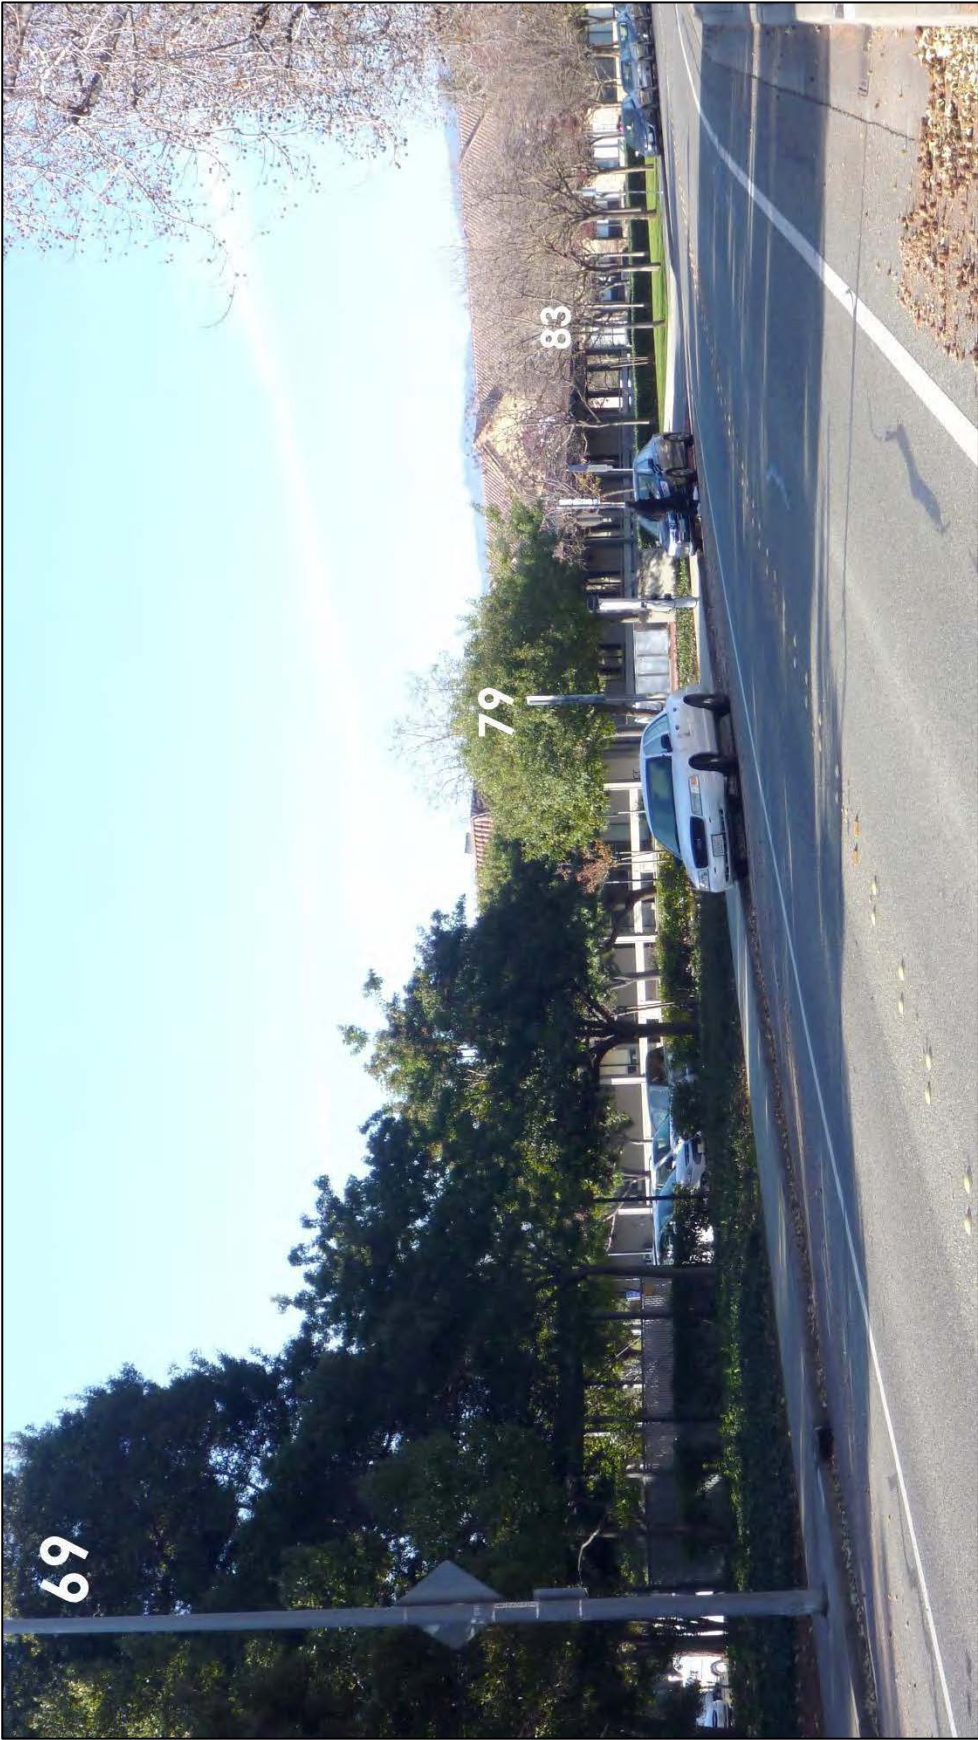
Rodrigues Avenue looking toward Torre Avenue to the right (not visible in photo). **Black acacia #69** is labeled, as is **Brazilian pepper #79** and **Chinese pistache #83**.

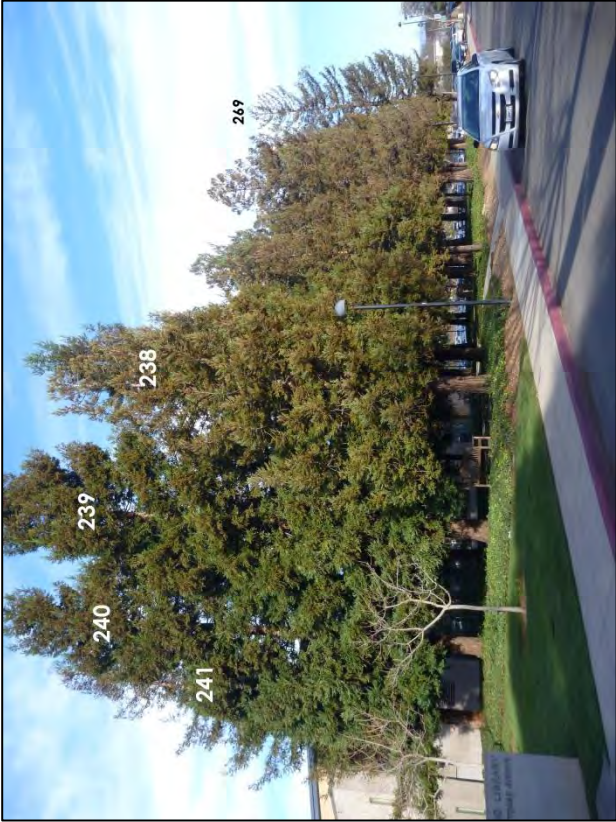
Upper Left: the grove of **coast redwoods #238-270** on the south side of the Library building.

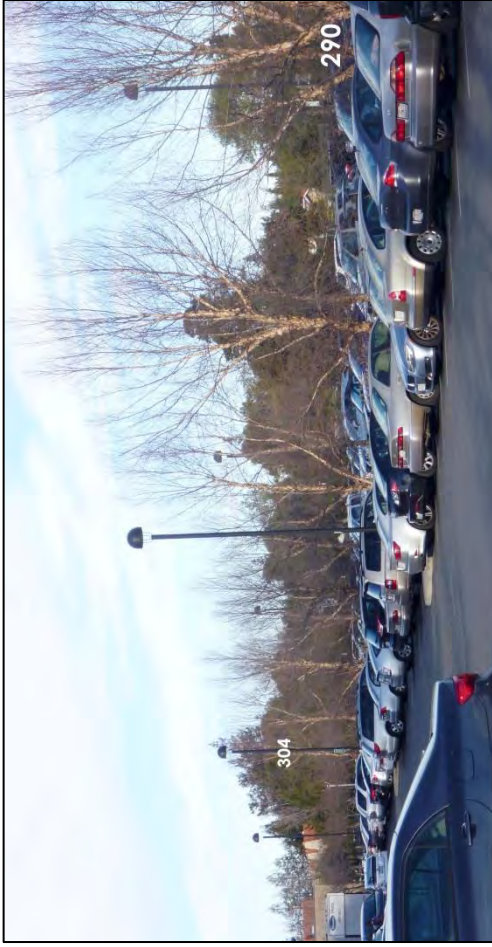
Upper Right: **river birch trees #290 - 304** planted in a bioswale in the Library parking lot.

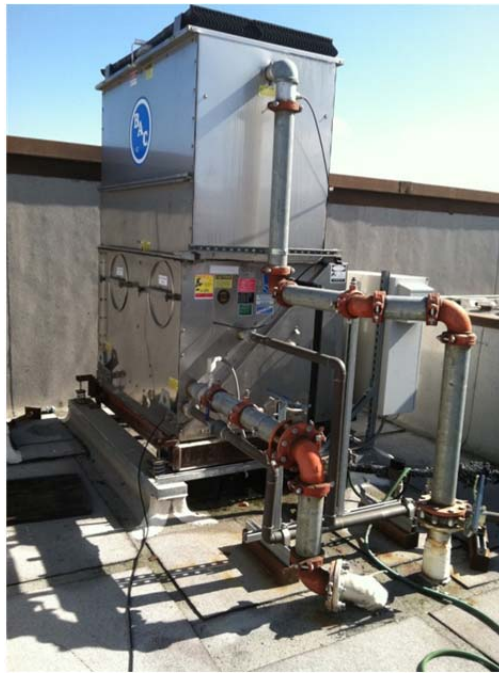
Figure 5A (Closed-Circuit 70 Ton Cooling Tower)

The HVAC system for the Cupertino City Hall consists of a water-cooled chiller plant (70 Ton) with the cooling tower located on the roof and the chiller located on the lower level. A gas fired non-condensing boiler generates heating hot water. The boiler is from the 1965 original building construction and is well past its life time. Both of these systems provide chilled and heating hot water to the Air Handling Units (AHU’s) located at the lower level that heat and cool the building through a VAV reheat design. All equipment was installed in ~1986 and is now 26 years old and at the end of its useful life. While the equipment appears to be well maintained, and the AHU’s have been retrofitted with VFD’s, the building operates inefficiently at a rate of \$3.63/SF-Year and 106 kBTU/SF-Year (based on 2009 utility bills). A modern, energy efficient office building operates at \$1.50/SF-Year and 50 kBTU/SF-Year.

In the lower level mechanical room, maintenance clearances and an exit pathway may not exist throughout the space. In addition, the combination of chiller, gas boiler, electrical gear, and generator equipment do not meet today's code

requirement to have separate rooms for each of these pieces of equipment. The room is also not equipped with a refrigerant detection and exhaust systems currently required for chiller rooms, and the combustion air ducts in the boiler room need to be routed to an outdoor location.

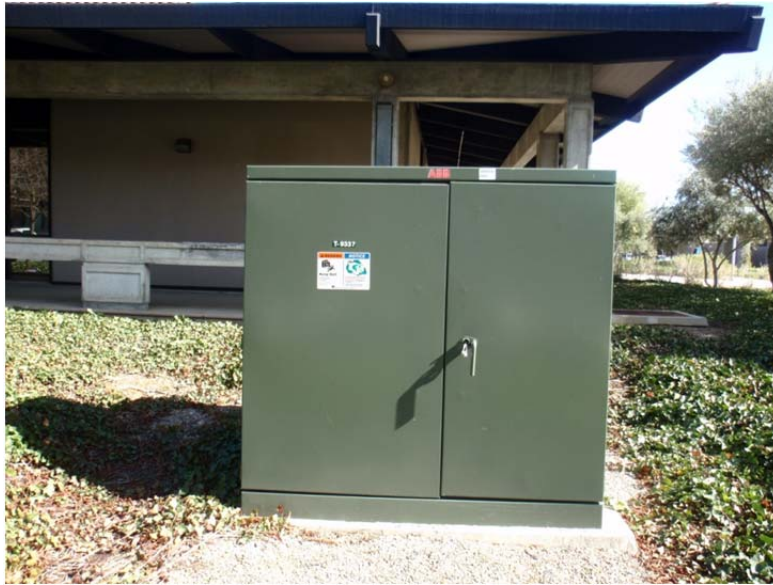
Figure 1E (PG&E Transformer)

The building is fed from a utility transformer (PG&E) located outside the building.

The secondary power from the transformer to the main switchboard is provided via (4) sets of 4" underground conduits.

The transformer belongs to PG&E and was recently upgraded. It appears to be in good working condition.

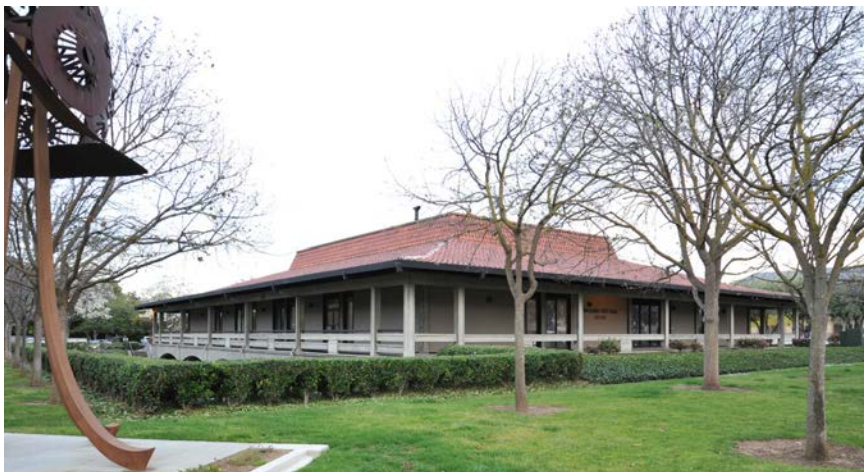
A: LIFE SAFETY UPGRADE

- Mechanical Equipment Relocation / Replacement
- Electrical Equipment Replacement
- Lighting Upgrades for T24 compliance
- \$2.78 / sf / year (vs \$3.65)
- 70kBtu / sf / year (vs 92kBtu)

- New Metal Roof
- Stair Upgrade
- Elevator replacement
- Accessibility Upgrades

- Life safety criteria implies significant damage to structure and non structural systems
- Facility relocation and downtime is anticipated
- Repairs may be costly or infeasible

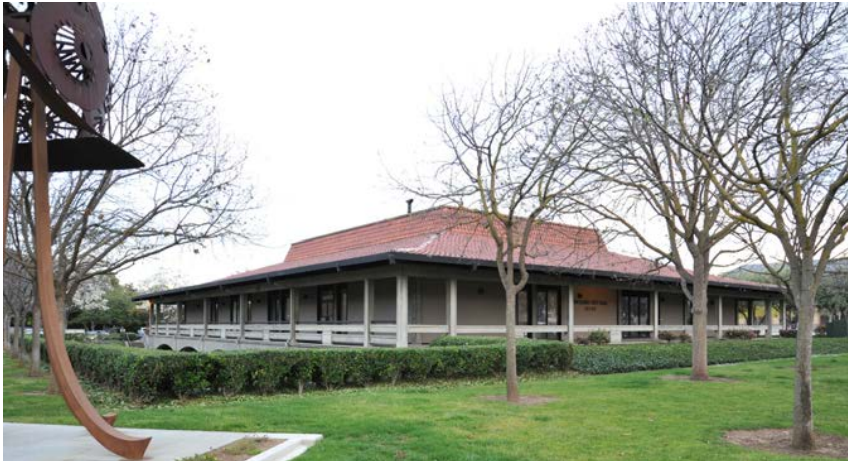
B: IMMEDIATE OCCUPANCY + EOC

STRUCTURAL (IMMEDIATE OCCUPANCY)

- Additional shear walls at ground level
- Seismic Bracing of MEP equipment
- Extensive Roof Reinforcement
- Concrete Column Reinforcement (Fiber Wrap required)
- Thickening of shear walls at basement

- Mechanical Equipment Relocation / Replacement
- Electrical Panels / Equipment Replacement
- Lighting Upgrades for T24 compliance
- \$2.78 / sf / year (vs \$3.65)
- 70kBtu / sf / year (vs 92kBtu)
- Generator Replacement
- Pipe Anchorage and Seismic Attachments

- New Roof Material
- Stair Upgrade
- Upgrade construction / finishes for fire rating
- Accessibility Upgrades
- Possible EOC Redesign
- Glazing replacement may be required if non tempered

- Prescriptive code criteria for Immediate Occupancy implies stronger structure
- Does not explicitly assure performance goals, relies on structural damage to absorb seismic energy
- May require costly repairs and facility downtime following major earthquake

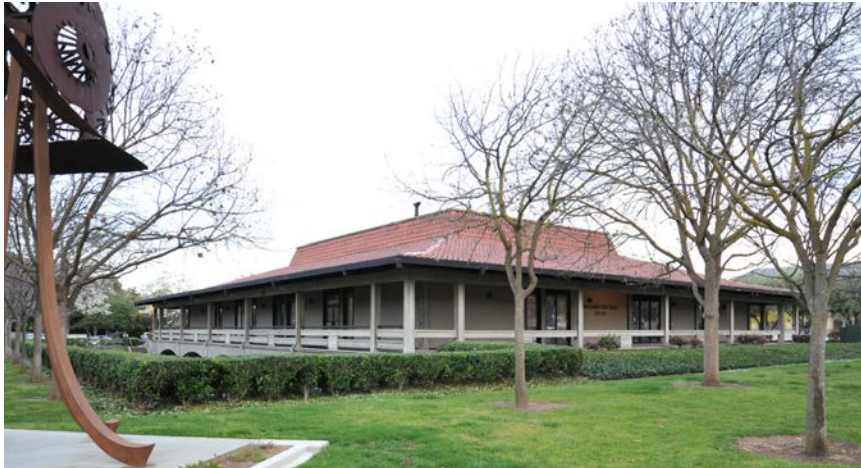
C: COMPLETE REMODEL

STRUCTURAL (IMMEDIATE OCCUPANCY)

- Additional shear walls at ground level
- Seismic Bracing of MEP equipment
- Extensive Roof Reinforcement
- Concrete Column Reinforcement (Fiber Wrap required)
- Thickening of shear walls at basement
- Additional slab reinforcement at lightwell openings

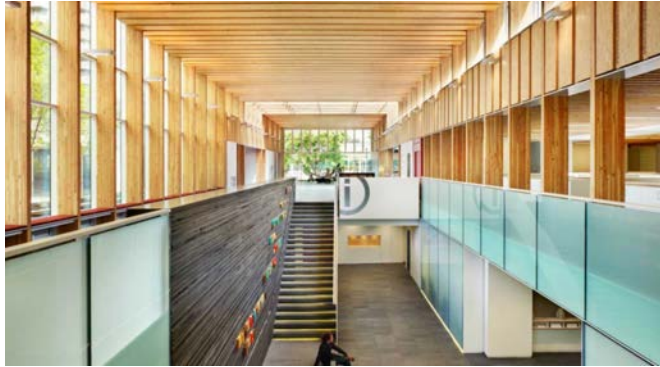
E: NEW BUILDING+ COUNCIL CHAMBERS

STRUCTURAL

- New Structure that will be designed to explicitly handle the seismic requirements for immediate occupancy
- 50 year life span

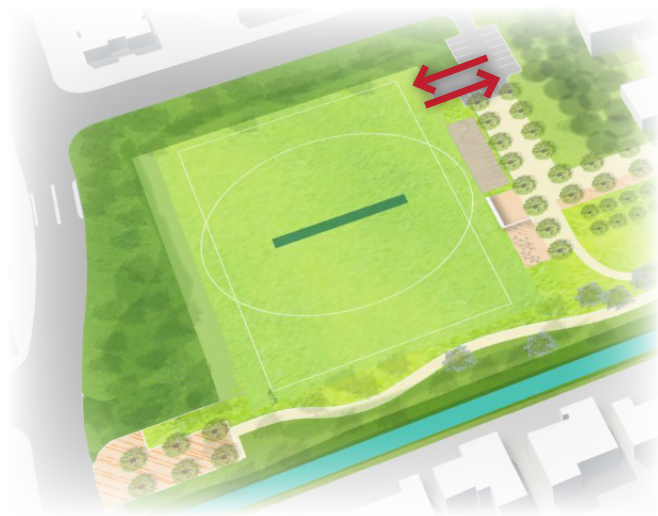
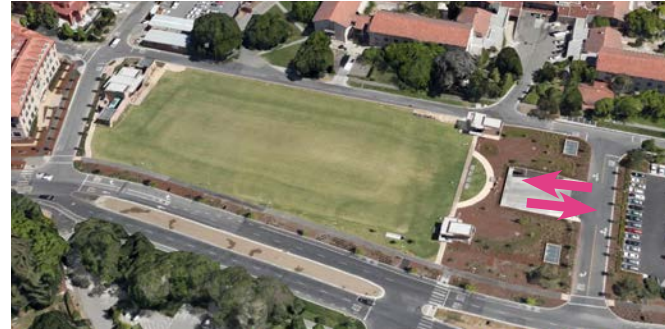
P1: UNDER LIBRARY FIELD

- Parking structure is entirely underground
- Accounts for an additional 100 spaces
- Field remains fully functional after construction
- Mechanically ventilated and artificially lit
- Accessible from Torre Avenue (with option to add secondary entrance/exit)
- Minimal visual obstruction above grade

- Construction Cost: \$5.3M (100 spaces = \$53k/space)
- 100 new spaces

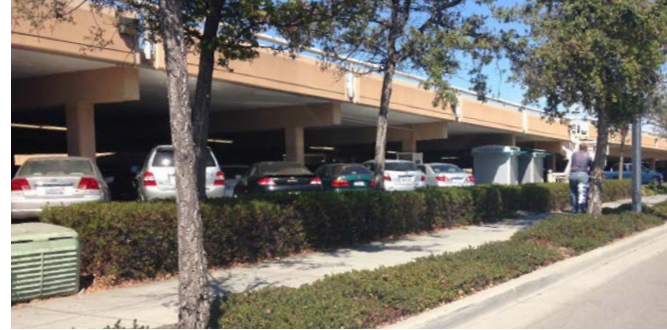
P2: BEHIND LIBRARY- ABOVE GROUND

Parking garage with 1 deck level (estimated at 15' high) located behind library on existing surface lot. Accounts for 100 additional spaces and replacement of 130 existing spaces.

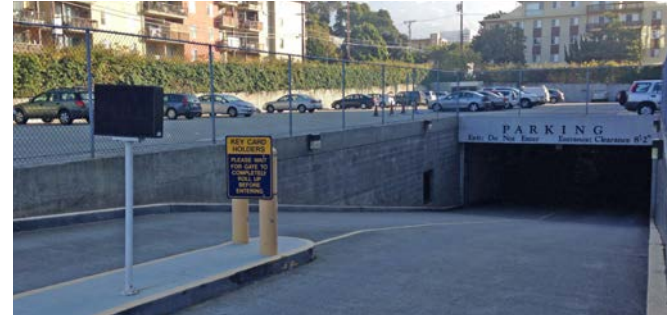
P3: BEHIND LIBRARY- BELOW GROUND

Parking garage with 1 level below ground located behind library on the existing surface lot. Accounts for 100 additional spaces and replacement of 130 existing spaces.

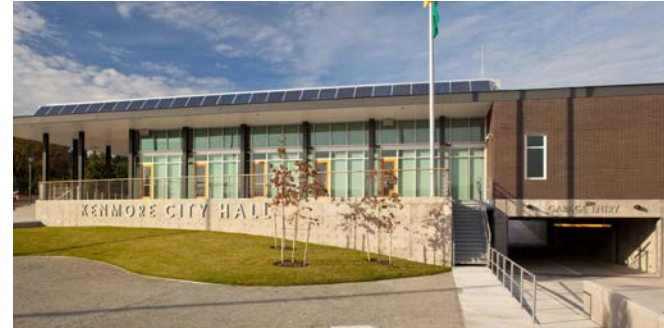
P4: BELOW NEW CITY HALL

Underground parking below a new City Hall.
Accounts for an additional 100 spaces.

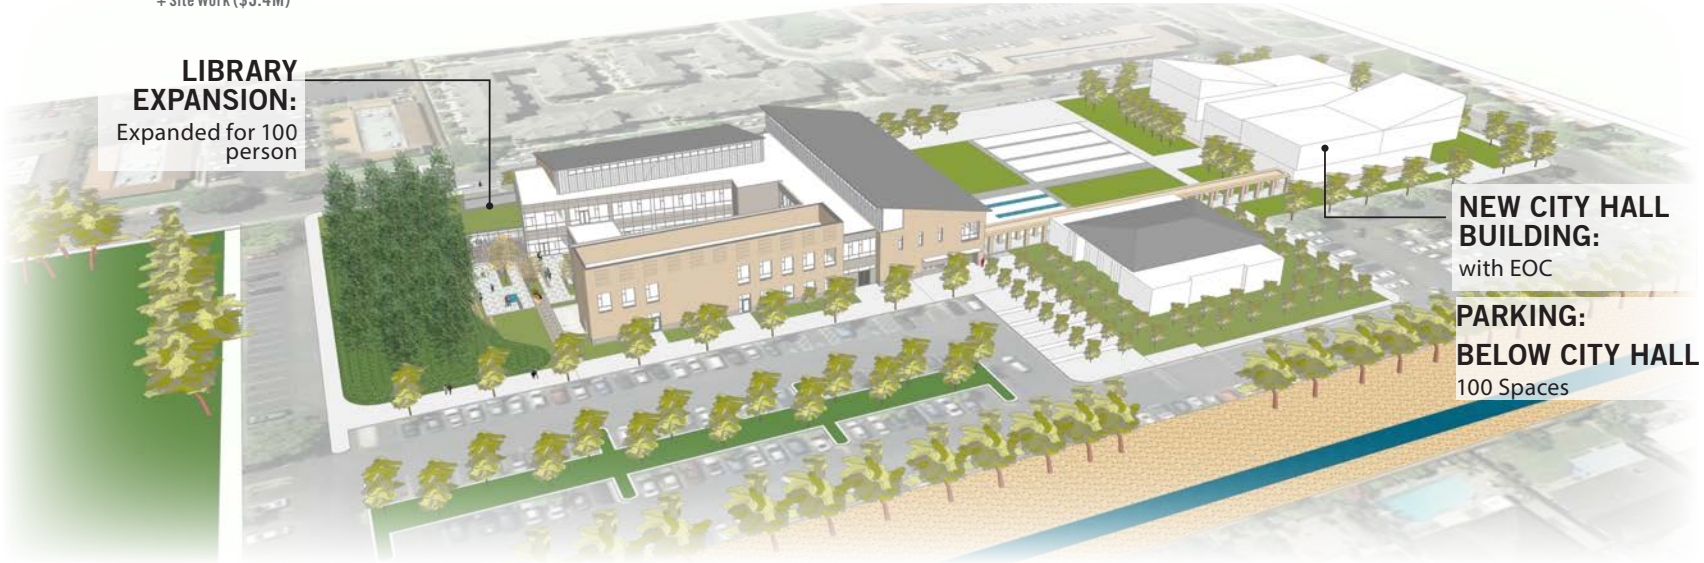
RECOMMENDED CCMP OPTION

D	New City Hall	L1 Expand Library (\$3.1M)	P4	New Building Basement (\$7M)	\$ 47.3M
	+ EOC (\$33.8M) + Site Work (\$3.4M)

LIBRARY EXPANSION:
Expanded for 100 person

NEW CITY HALL BUILDING:
with EOC

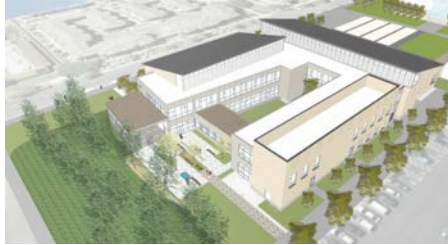
OPTION 1: WEST WING EXPANSION

1. Most Compact Addition
2. Cost Effective
3. Does Not affect the rest of Library Program

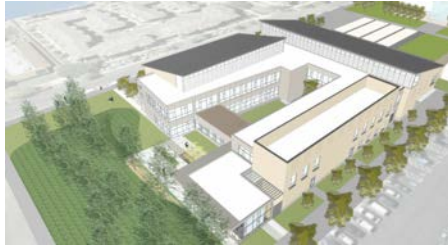
OPTION 2: EAST WING EXPANSION

1. Compact Addition
2. Cost Effective
3. Ideal / Flexible Room Shape
4. Ideal Ceiling Heights Achievable
5. Adjacent to Existing Mechanical Equipment / Penthouse
6. Minimal Impact to Memorial Grove Trees
7. Possible retention of Existing Story Room
8. Minimum Disruption of Library Operations
9. Can Accomodate 130 seats with minimum impact to Memorial Grove
10. Adjacent to Existing Parking (Easy Visibility)

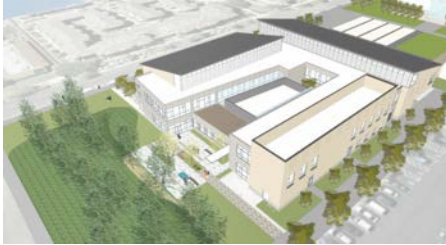
OPTION 3: COURTYARD INFILL

1. Ideal Ceiling Heights Achievable
2. No Impact to Memorial Grove Trees
3. Can Accomodate 130-150 seats

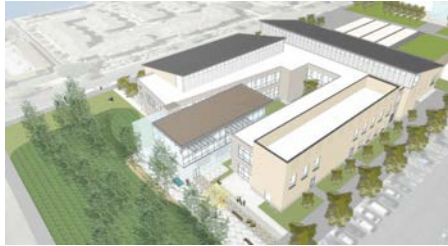
OPTION 4: “PERCH” ADDITION

1. Ideal Ceiling Heights Achievable
2. Room Shape is ideal / flexible
3. No Impact to Memorial Grove Trees
4. Easy Visibility from Parking
5. Adjacent to existing Mechanical Penthouse
6. More Roof Surface for Photovoltaics
7. Minimum impact to permeable surfaces
8. Optimal views to outside
9. Retention of Existing Story Room
10. Minimal disruption of Library during construction (no relocation)
